Level 1 Full Reserve Study (With Site-Visit)

Prepared For Fiscal Year 2020

May 28, 2019

Name	
Location	Daytona Beach, FL 32118
Units/General Type	42 / Condominium
Base Year / Age	1981 / 38
Fiscal Year Ends	December-31

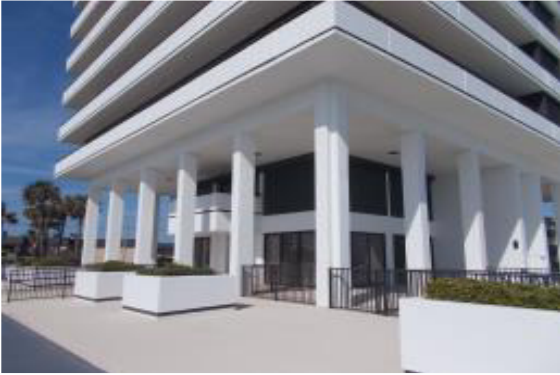
<i>Reserve Component</i>	<i>Quantity</i>	<i>Unit of Measure</i>	<i>Unit Cost</i>	<i>Source Code</i>	<i>Rplc %</i>	<i>Cont %</i>	<i>Extended Cost</i>
01 Coat/Paint/Stain							
01.01 Exterior Paint 24 Floors exterior painting and sealing UL: 10 RL: 7	24	each	\$15,800.00	8	100%	5%	\$398,160

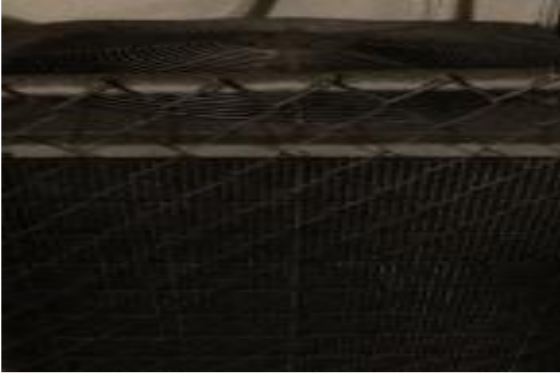
02 Equipment							
02.01 A/C Units 1- 5 ton 1- 6 ton Supply to common areas Includes supply lines and electrical labor costs UL: 20 RL: 10	2	units	\$6,950.00	8	100%	5%	\$14,595

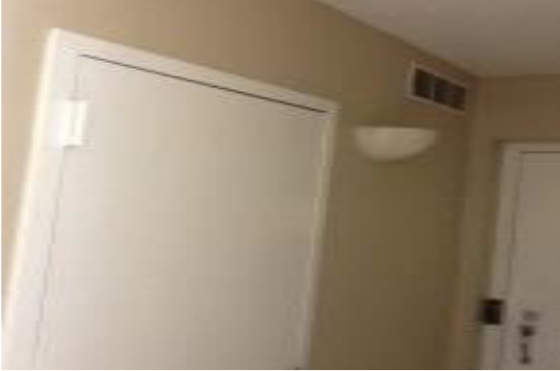
<i>Reserve Component</i>	<i>Quantity</i>	<i>Unit of Measure</i>	<i>Unit Cost</i>	<i>Source Code</i>	<i>Rplc %</i>	<i>Cont %</i>	<i>Extended Cost</i>
02 Equipment							
02.02 Building Security System & Cameras Whole building (30,250) Security system including cameras, electrical supply, and wiring to office monitors UL: 15 RL: 12	1	units	\$35,700.00	8	100%	5%	\$37,485

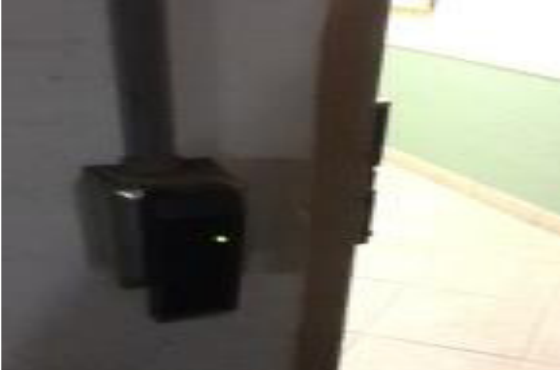
02.03 Door Key Fob System (entrance & exit) Keyless entry fob system including 14 fob readers, wiring and installation UL: 20 RL: 12	14	each	\$2,570.00	9	100%	5%	\$37,779

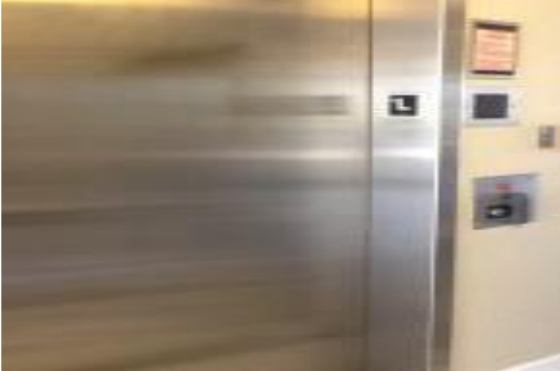
02.04 Elevators 2 elevators inside building including cars, motors, and cables UL: 40 RL: 30	2	units	\$58,750.00	12	100%	5%	\$123,375

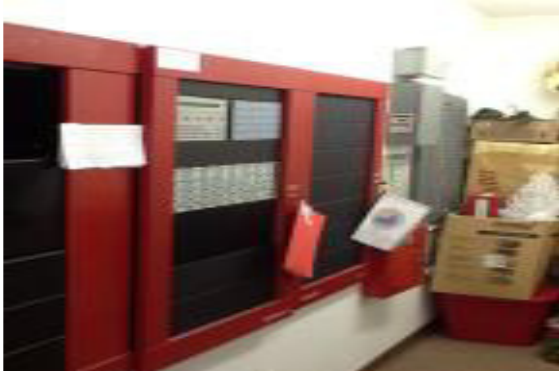
<i>Reserve Component</i>	<i>Quantity</i>	<i>Unit of Measure</i>	<i>Unit Cost</i>	<i>Source Code</i>	<i>Rplc %</i>	<i>Cont %</i>	<i>Extended Cost</i>
02 Equipment							
02.05 Fire Alarm System 25 hoses, 34 fire extinguishers, 126 sprinklers, 87 smoke alarms, 42 heat sensors, and 82 speakers. Includes installation and electrical.							\$92,689
02.05.1 Fire Extinguishers 34 fire extinguishers, rated for chemical fires	34	each	\$778.00	9	100%	5%	\$27,774
02.05.2 Fire Speakers 82 smoke alarm speakers	82	each	\$115.00	7	100%	5%	\$9,901
02.05.3 Heat Sensors 42 heat sensors for fire system	42	units	\$160.00	7	100%	5%	\$7,056
02.05.4 Hoses 25 fire hoses	25	each	\$525.00	12	100%	5%	\$13,781
02.05.5 Smoke Alarms 87 smoke alarms	87	each	\$70.00	7	100%	5%	\$6,394
02.05.6 Sprinklers 126 sprinkler heads including installation UL: 25 RL: 21	126	units	\$210.00	8	100%	5%	\$27,783

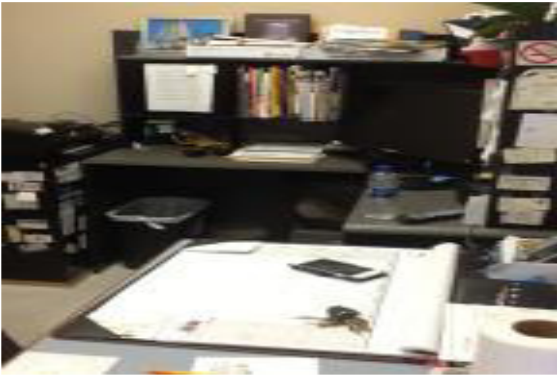
<i>Reserve Component</i>	<i>Quantity</i>	<i>Unit of Measure</i>	<i>Unit Cost</i>	<i>Source Code</i>	<i>Rplc %</i>	<i>Cont %</i>	<i>Extended Cost</i>
02 Equipment							
02.06 Office Equipment							\$13,891
Computer, monitor, software, lighting, electrical supply, and telephone system located in office.							
02.06.1 Computer, Monitor, Software and backup system	1	each	\$5,000.00	8	100%	5%	\$5,250
Computer, software, Monitor, and backup file system included							
02.06.2 Lighting and Electrical	1	each	\$2,000.00	8	100%	5%	\$2,100
Lighting, wiring and installation							
02.06.3 Telephone System	1	each	\$6,230.00	8	100%	5%	\$6,541
Office telephone system including installation, answering system and equipment for operation

UL: 10 RL: 6

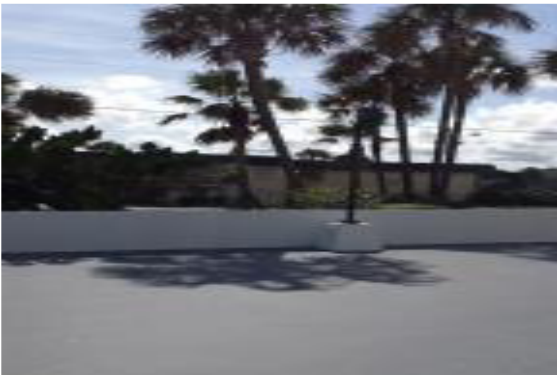
02.07 Parking Area Lights	11	units	\$1,969.00	7	100%	5%	\$22,741
11 parking lights on ground level including installation , electrical supply and risers							
UL: 25 RL: 5

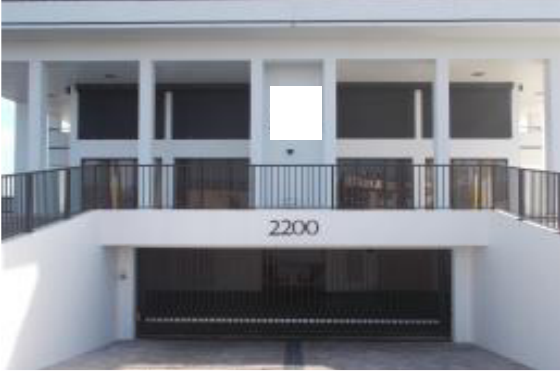
<i>Reserve Component</i>	<i>Quantity</i>	<i>Unit of Measure</i>	<i>Unit Cost</i>	<i>Source Code</i>	<i>Rplc %</i>	<i>Cont %</i>	<i>Extended Cost</i>
02 Equipment							
02.08 Sign Lighting Illuminating sign lights UL: 40 RL: 2	2	each	\$2,382.00	7	100%	5%	\$5,002

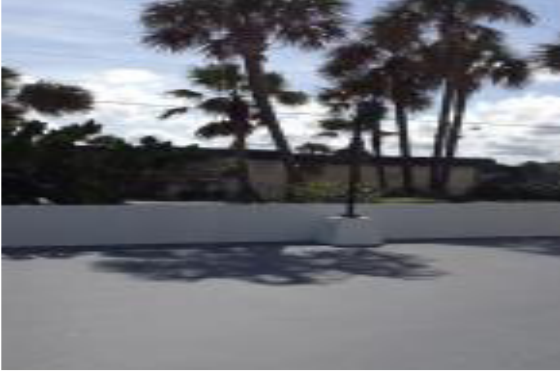
<i>Reserve Component</i>	<i>Quantity</i>	<i>Unit of Measure</i>	<i>Unit Cost</i>	<i>Source Code</i>	<i>Rplc %</i>	<i>Cont %</i>	<i>Extended Cost</i>	
04 Pavement								
04.01	Concrete Coating Restoration	1	bldgs	\$68,326.00	7	100%	5%	\$71,742
	Concrete restoration of parking area underground in garage and on ground level							
	UL: 30	RL: 26

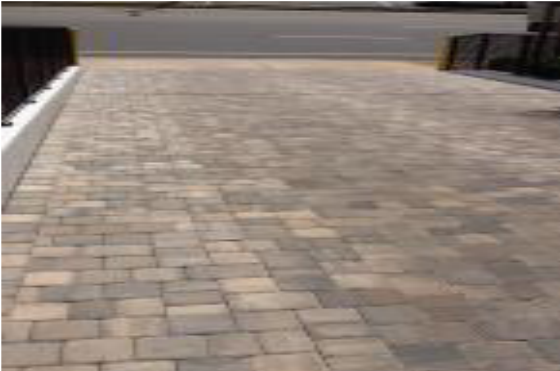
04.02	Paver Walkways	293	sq ft	\$156.00	8	100%	5%	\$47,993
	293 lin Ft patio pavers/ walkway including front entrance & exit							
	UL: 50	RL: 12

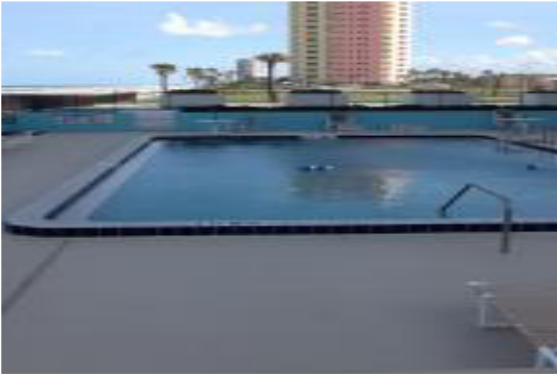
<i>Reserve Component</i>	<i>Quantity</i>	<i>Unit of Measure</i>	<i>Unit Cost</i>	<i>Source Code</i>	<i>Rplc %</i>	<i>Cont %</i>	<i>Extended Cost</i>
05 Pools/Spas							
05.01 Pool Area Pool, spa, pump, pump house, resurfacing and surrounding pathways							\$95,642
05.01.1 Pool Pump Pool pump , supply lines and installation	1	each	\$22,560.00	7	100%	5%	\$23,688
05.01.2 Pool Resurfacing Condo assoc pool resurfacing including drainage, repair and refill	1	each	\$30,264.00	8	100%	5%	\$31,777
05.01.3 Pump House Pool pump house including electrical supply , constuction and roofing	1	bldgs	\$38,264.00	12	100%	5%	\$40,177
UL: 25 RL: 10

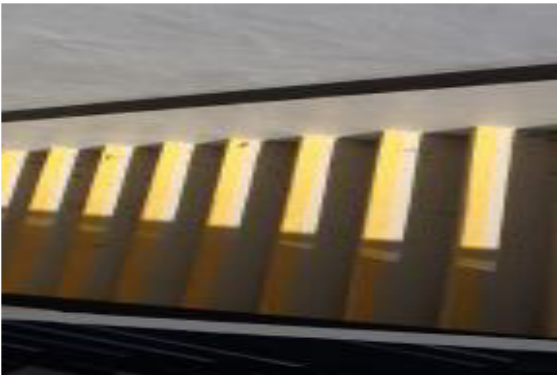
06 Restoration							
06.01 Concrete Steps 7 sets concrete steps including installation	7	each	\$5,250.00	12	100%	5%	\$38,587
UL: 40 RL: 15

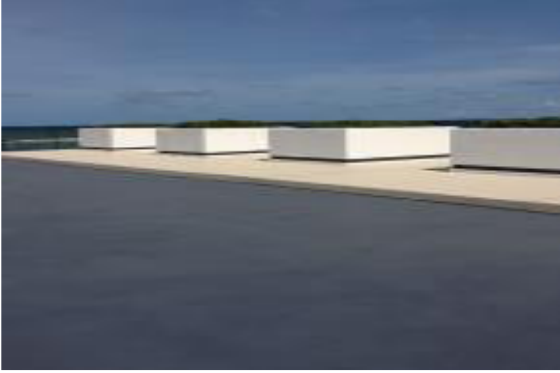
<i>Reserve Component</i>	<i>Quantity</i>	<i>Unit of Measure</i>	<i>Unit Cost</i>	<i>Source Code</i>	<i>Rplc %</i>	<i>Cont %</i>	<i>Extended Cost</i>
06 Restoration							
06.02 Landscaping 16 6' x 6' planter boxes including plants and refurbish of containers UL: 15 RL: 12	16	units	\$5,235.00	9	100%	5%	\$87,948
