Level 2 Reserve Study Update (With Site-Visit)

Prepared For Fiscal Year 2020

July 10, 2019

Name	
Location	Orlando, FL 32836
Units/General Type	60 / Planned Development (PD)
Base Year / Age	2003 / 16
Fiscal Year Ends	December-31

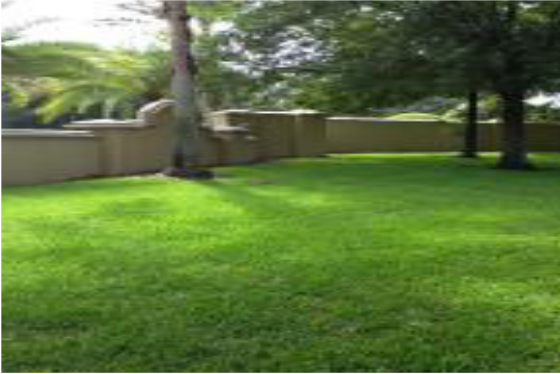
02.02	Perimeter Walls UL: 7 RL: 6 Approximately 1840 lin ft of stucco wall with 25500 sq ft of surface. Perimeter wall paint and repair only. Some places in need of repair - see photos.	1	each	\$15,600.00	5	100%	5%	\$16,380

<i>Reserve Component</i>	<i>Quantity</i>	<i>Unit of Measure</i>	<i>Unit Cost</i>	<i>Source Code</i>	<i>Rplc %</i>	<i>Cont %</i>	<i>Extended Cost</i>
02 Fencing							
02.02	Perimeter Walls	1 each	\$15,600.00	5	100%	5%	\$16,380
	Approximately 1840 lin ft of stucco wall with 25500 sq ft of surface. Perimeter wall paint and repair only. Some places in need of repair - see photos. UL: 7 RL: 6

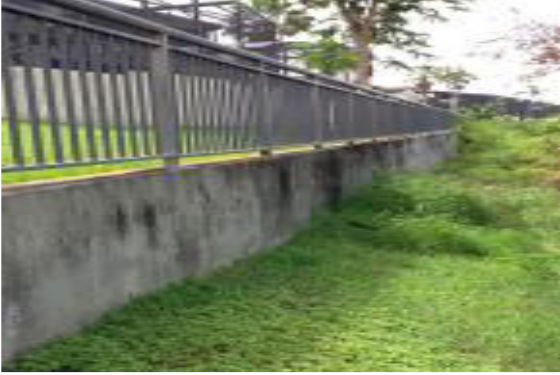
02.03	Retaining Walls UL: 30 RL: 15 1840 lin ft retaining wall shows erosion and signs of repair. Cracking along top edges (minimal) . Estimate comprised of removal and replacement of complete wall.	1,840	lin ft	\$65.00	6	100%	5%	\$125,580
03 Pavement

02.03	Retaining Walls	1,840 lin ft	\$65.00	6	100%	5%	\$125,580
	1840 lin ft retaining wall shows erosion and signs of repair. Cracking along top edges (minimal) . Estimate comprised of removal and replacement of complete wall. UL: 30 RL: 15

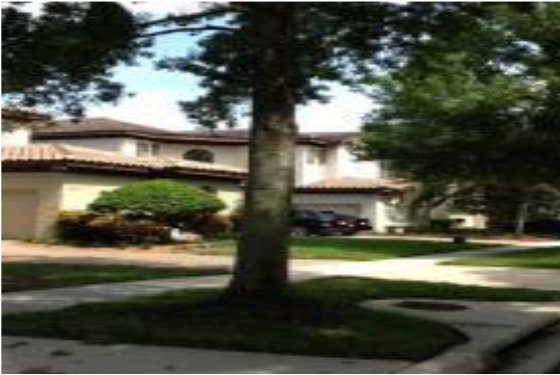
03.01	Aprons (repaired in 2019) UL: 35 RL: 34 Concrete aprons replacement due to tree roots raising pads to unacceptable levels.	4	each	\$2,300.00	3	100%	5%	\$9,660

03 Pavement							
03.01	Aprons (repaired in 2019)	4 each	\$2,300.00	3	100%	5%	\$9,660
	Concrete aprons replacement due to tree roots raising pads to unacceptable levels. UL: 35 RL: 34

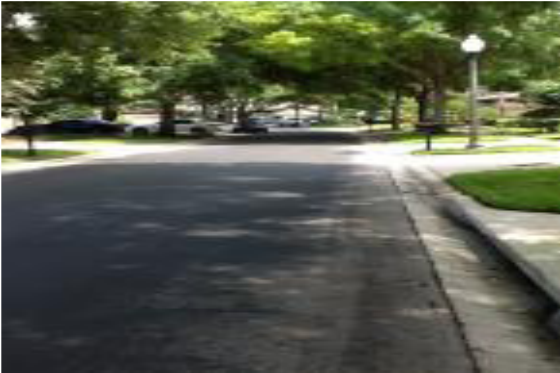
03.02	Aprons (not replaced in 2019) UL: 35 RL: 5 Replacement of aprons due to trees roots upheaving pads to unacceptable level	56	each	\$2,100.00	5	100%	5%	\$123,480

<i>Reserve Component</i>	<i>Quantity</i>	<i>Unit of Measure</i>	<i>Unit Cost</i>	<i>Source Code</i>	<i>Rplc %</i>	<i>Cont %</i>	<i>Extended Cost</i>
03 Pavement							
03.02 Aprons (not replaced in 2019) Replacement of aprons due to trees roots upheaving pads to unacceptable level UL: 35 RL: 5	56	each	\$2,100.00	5	100%	5%	\$123,480

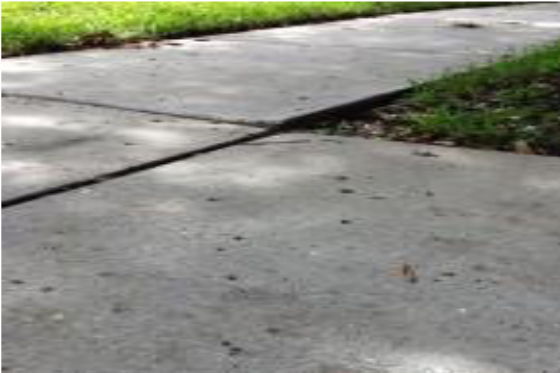
03.04 Concrete Sidewalks UL: 35 RL: 15 Concrete sidewalks normal wear and tear has been deminished by tree roots upheaving sidewalks in various places through out community. 59 panels were replaced in 2019 and 2017.	14,100	sq ft	\$5.50	5	100%	5%	\$81,428
04 Restoration

03.04 Concrete Sidewalks Concrete sidewalks normal wear and tear has been deminished by tree roots upheaving sidewalks in various places through out community. 59 panels were replaced in 2019 and 2017. UL: 35 RL: 15	14,100	sq ft	\$5.50	5	100%	5%	\$81,428

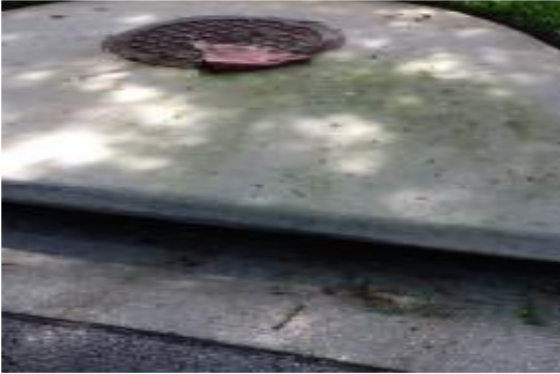
04.01 Drainage Basins Repair (with partial replacement) UL: 20 RL: 8 7 "catch" basins on sides of streets.	7	each	\$825.00	6	100%	5%	\$6,063
04.02 Monument Signs UL: 30 RL: 20 2 monument signs at entrance. Painted in 2019. Includes immediate lighting, landscaping and graphics.	2	units	\$2,850.00	8	100%	5%	\$5,985

<i>Reserve Component</i>	<i>Quantity</i>	<i>Unit of Measure</i>	<i>Unit Cost</i>	<i>Source Code</i>	<i>Rplc %</i>	<i>Cont %</i>	<i>Extended Cost</i>
04 Restoration							
04.01 Drainage Basins Repair (with partial replacement) 7 "catch" basins on sides of streets. UL: 20 RL: 8	7	each	\$825.00	6	100%	5%	\$6,063

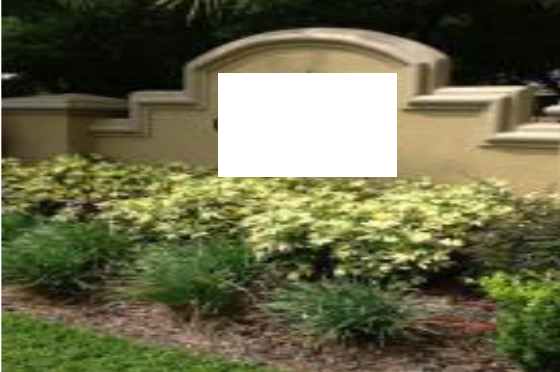
04.02 Monument Signs 2 monument signs at entrance. Painted in 2019. Includes immediate lighting, landscaping and graphics. UL: 30 RL: 20	2	units	\$2,850.00	8	100%	5%	\$5,985

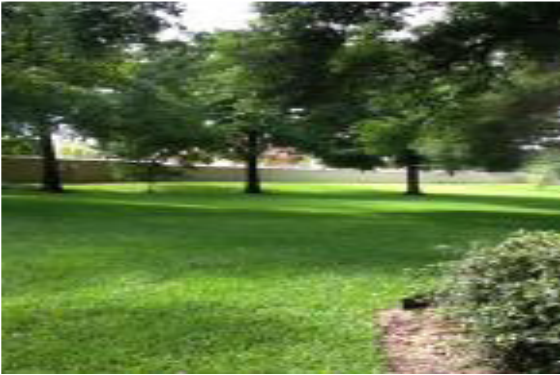
04.03 Tree Maintenance Tree maintenance allowance as requested by board for yearly trimming. UL: 1 RL: 1	130	each	\$250.00	7	100%	5%	\$34,125
